Manhole Inspection Summary

Manhole # S23WW1017MH

Insp Date: **2/21/07 2:27 PM**

Location Address: **17 ELMWOOD RD**

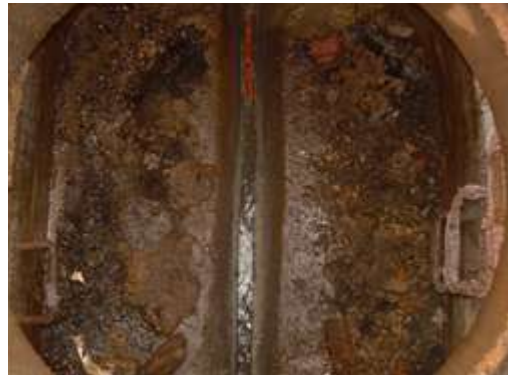
Top View

Steps Count: **3** Missing: **0** ☒ **Corroded**

Surcharge ☒ **Evidence Of Surcharge** Depth: **1** (ft.) ☐ Active Surcharge Present

Corroded steps. Evidence of surcharge - Bench debris.

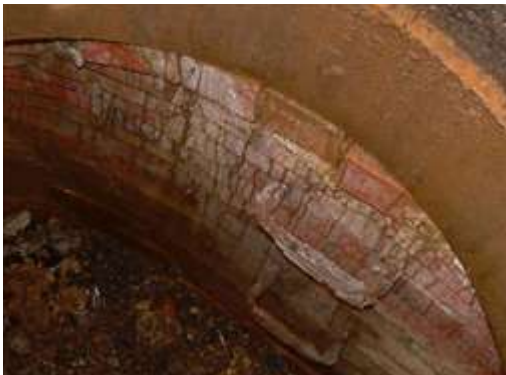
Defect

Frame Offset: **0** (in.) Condition: ☐ Sound ☐ Cracked ☒ **Leaks**

Condition: ☐ Sound ☐ Cracked ☐ Root Intrusion ☒ **Loose Brick** ☒ **Deteriorated**

Infiltration: ☐ None ☒ **Joint** ☐ Cracks ☒ **Mortar** ☐ Roots ☐ Wall

Frame leaks. Corbel deterioration, loose brick and infiltration.

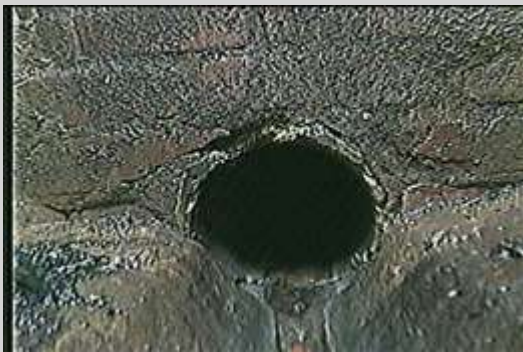
6 in. Circular Gravity Sewer Pipe Out @ 12 O'Clock

Infiltration: **None** Pipe Seal Cond: **Broken**

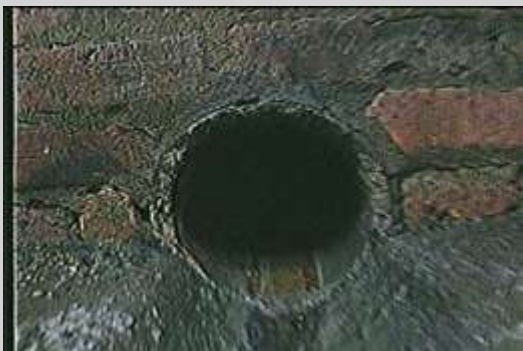
6 in. Circular Gravity Sewer Pipe In @ 6 O'Clock

Condition: ☐ Sound ☐ Cracked ☐ Root Intrusion ☐ Loose Brick ☒ **Deteriorated**

Infiltration: ☐ None ☐ Joint ☐ Cracks ☒ **Mortar** ☐ Roots ☒ **Wall**

Barrel deterioration and infiltration.
